# ACCELERATED WEATHERING TESTS OF SOLDERED AND TINNED SHEET COPPER

By Peter R. Kosting<sup>1</sup>

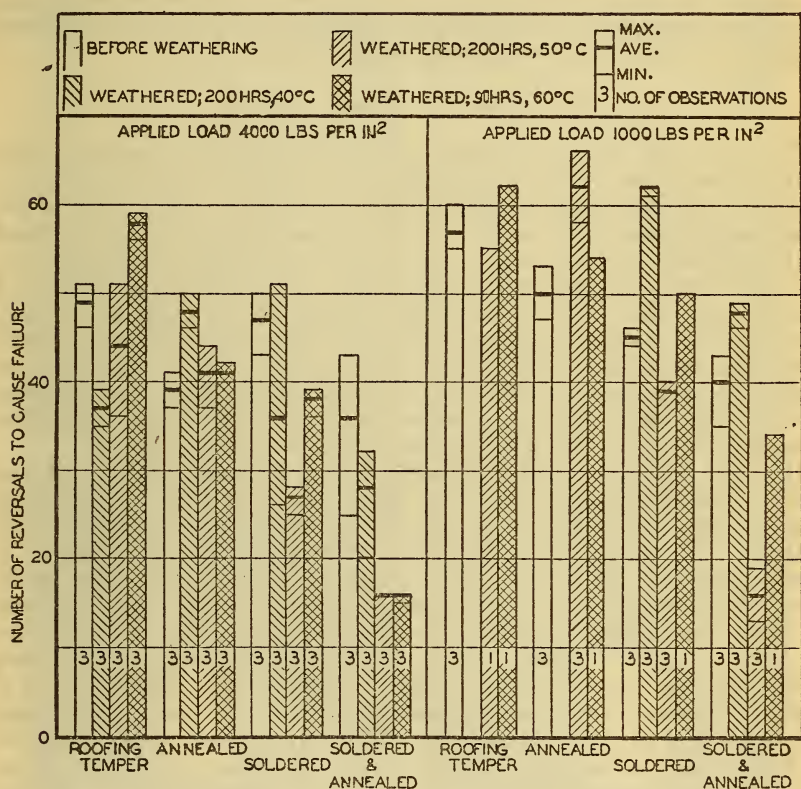
FIGURE 6.—Results of bend tests of plain and soldered sheet copper

In Tables 4 and 5 and in Figure 6 are given the results of accelerated weathering of soldered copper. At the end of the first 100-hour period many of the specimens were found, after scrubbing, drying, and weighing, to have increased in weight, and after 200 hours very slight losses were noticeable. However, after removing the corrosion film by pickling considerable loss in weight was observed. The reported corrosion rates for soldered copper were calculated on the assumption that all the loss was from the bare copper portion whose area was very nearly 50 per cent of the total area exposed. These figures indicate that the corrosion rate of soldered copper increased with increase in annealing temperature to which the solder was subjected.
